Erica Christiansen

Remote Sensing Solutions: Quantifying Monarch Butterfly Habitat in Transportation Right-of-Way

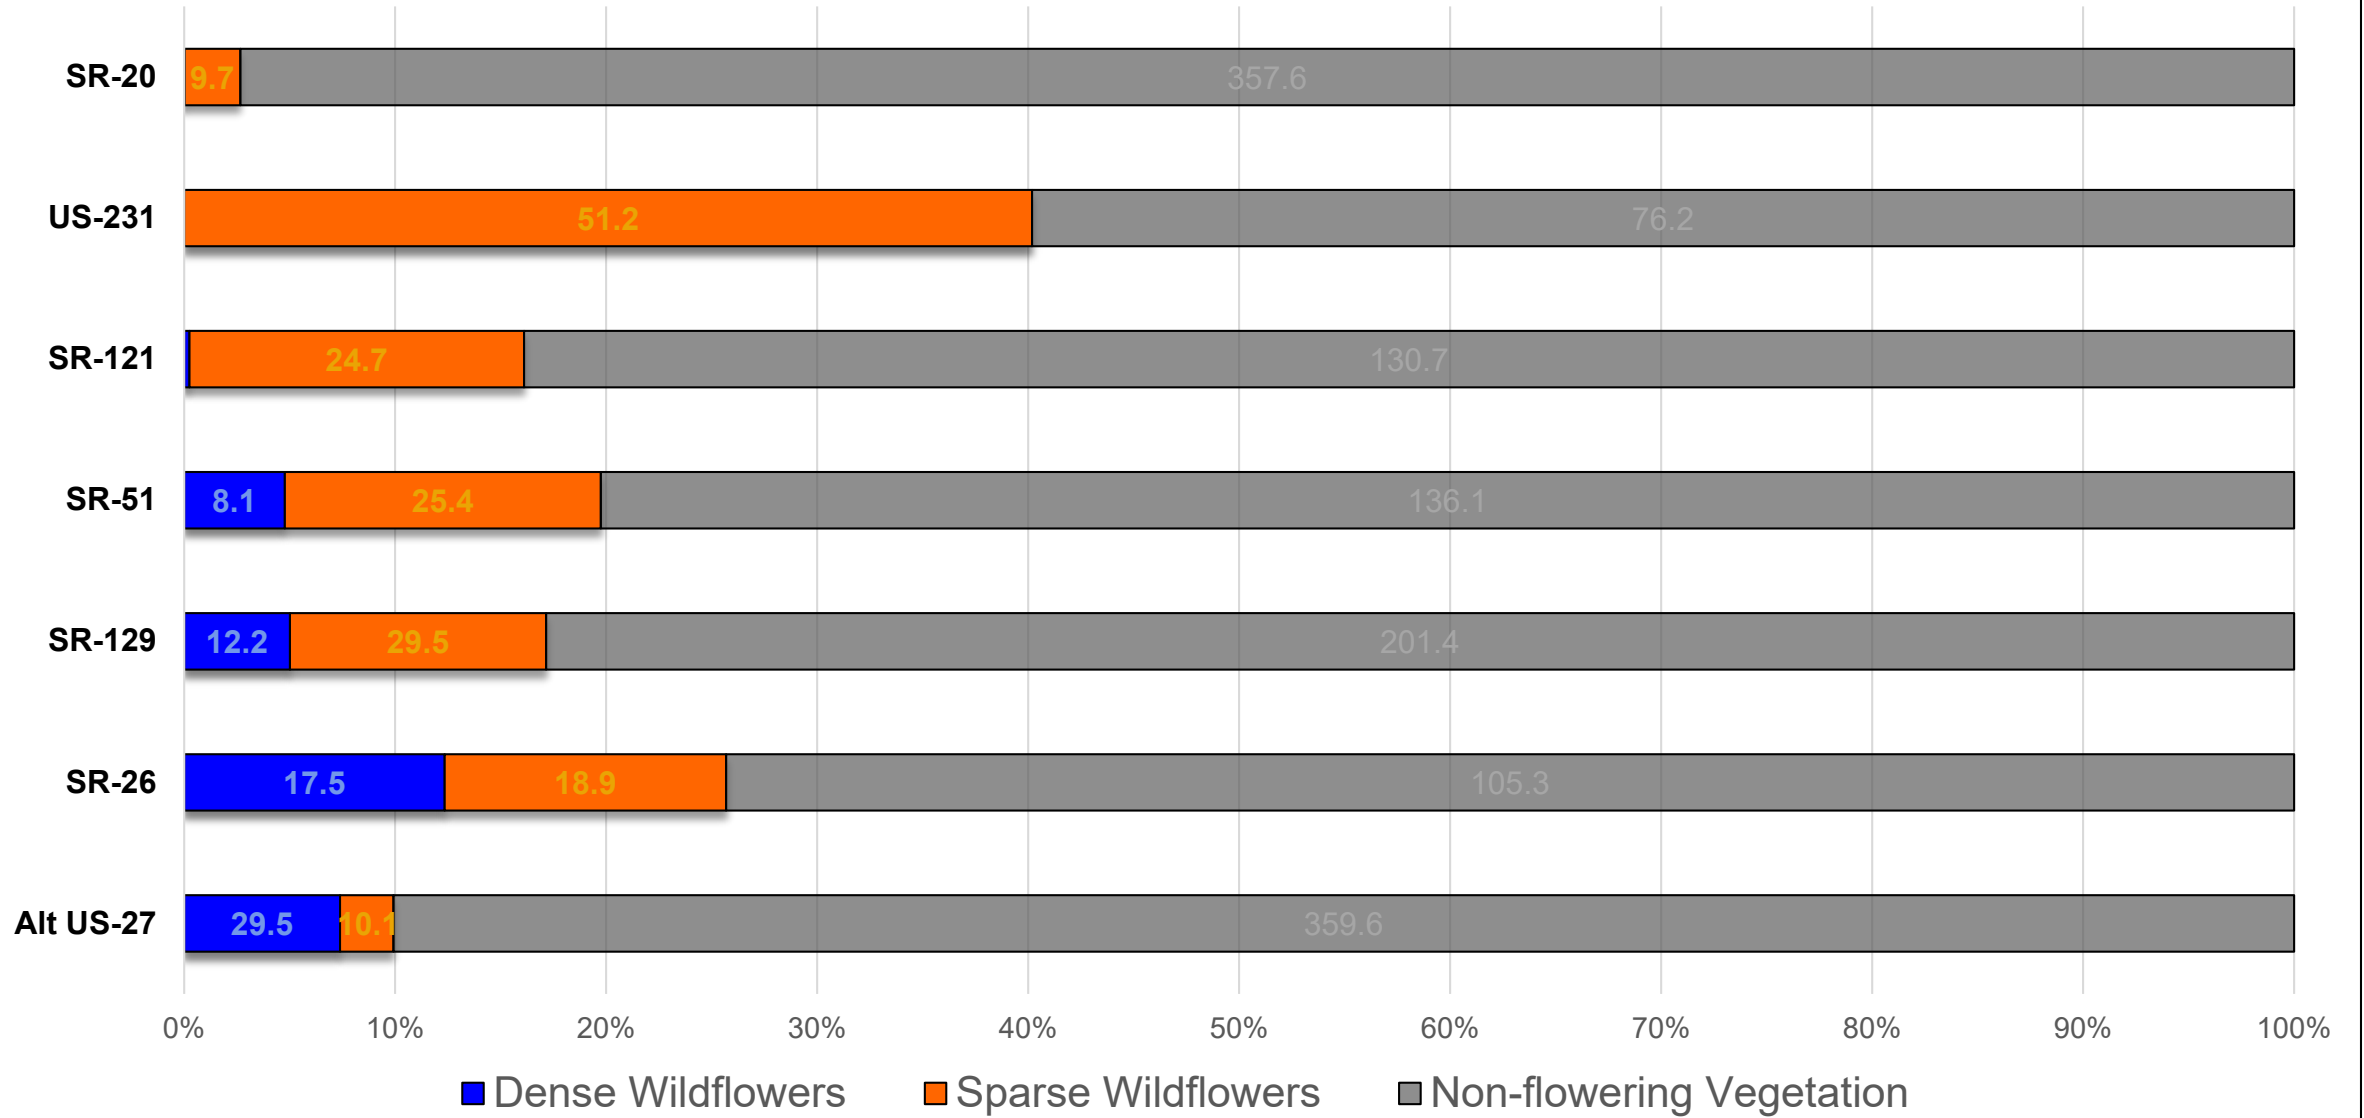
Object-Based Image Analysis Results: Proportion of Right-of-Way Conditions
